BLIGHT OR BRIGHT

THE CITY OF BALL GROUND
NEVER ENDING
JOURNEY

BALL GROUND EXAMPLE

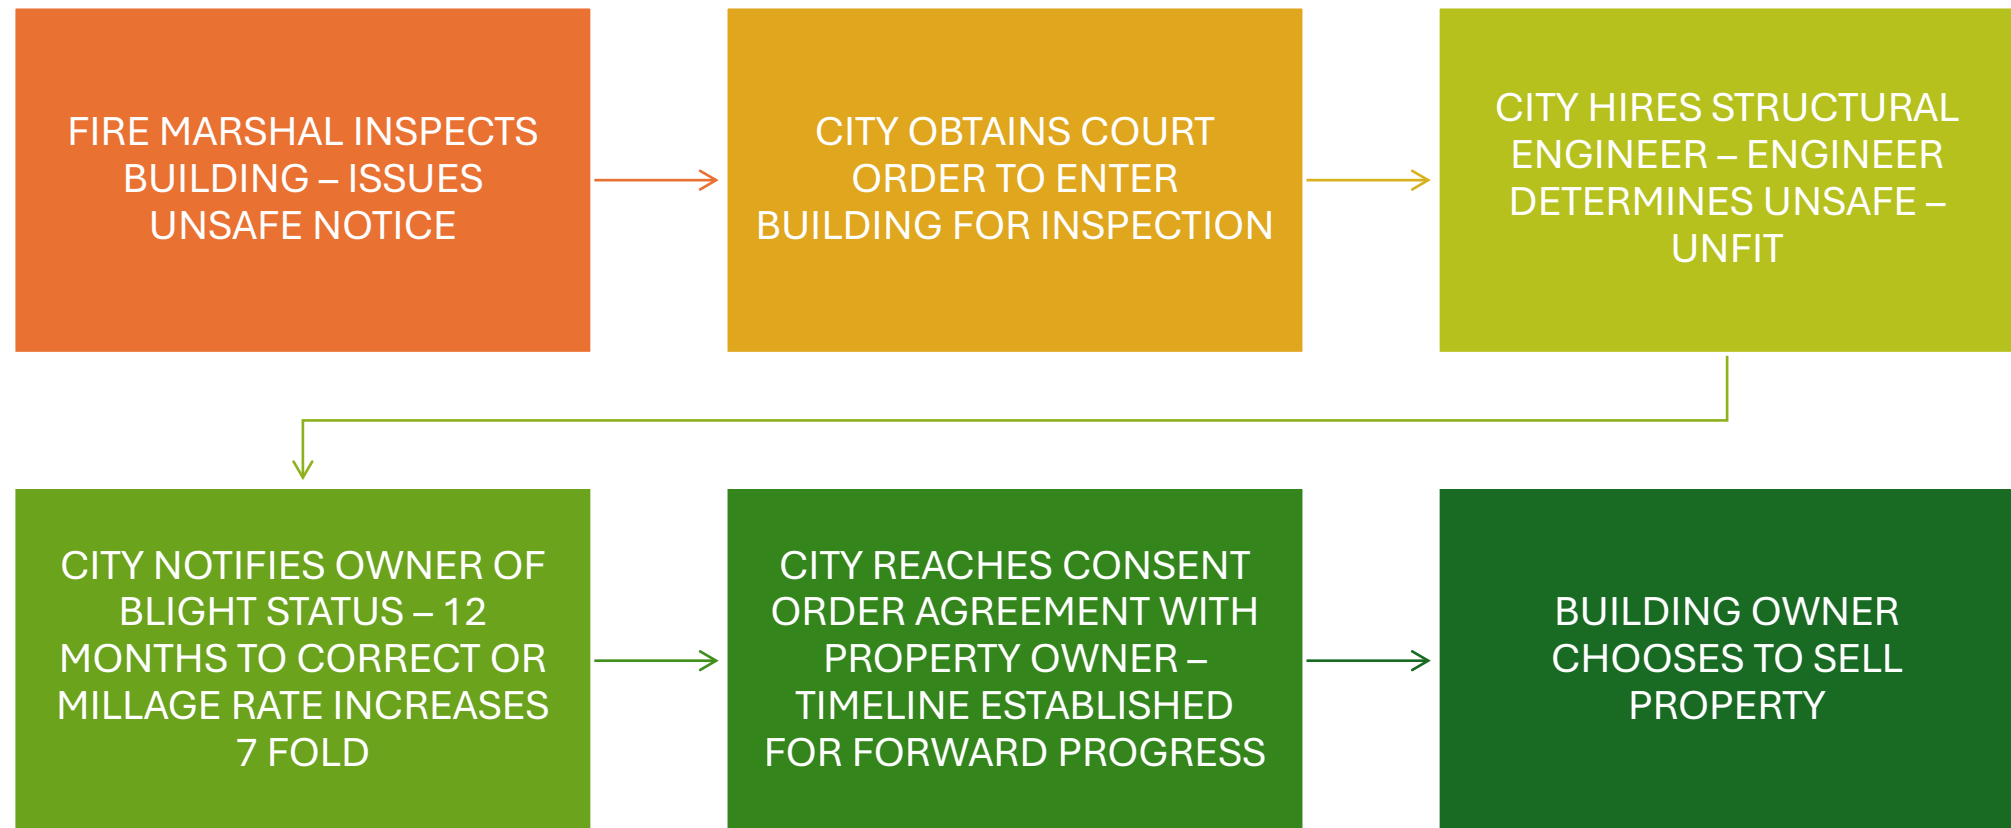
Other Finding 04/25/2022 \$0.00

With the following conditions of the building. This location falls under the attention of the Fire Codes below...

Per International Fire Codes 111.1 , 111.1.1 , 111.1.2

There are major concerns with the safety of the individuals inside the building.

The basic safeties such as fire extinguishers and clear exit paths, and clear exits, but also the major ones such as the Structural deterioration of the floor and roof.

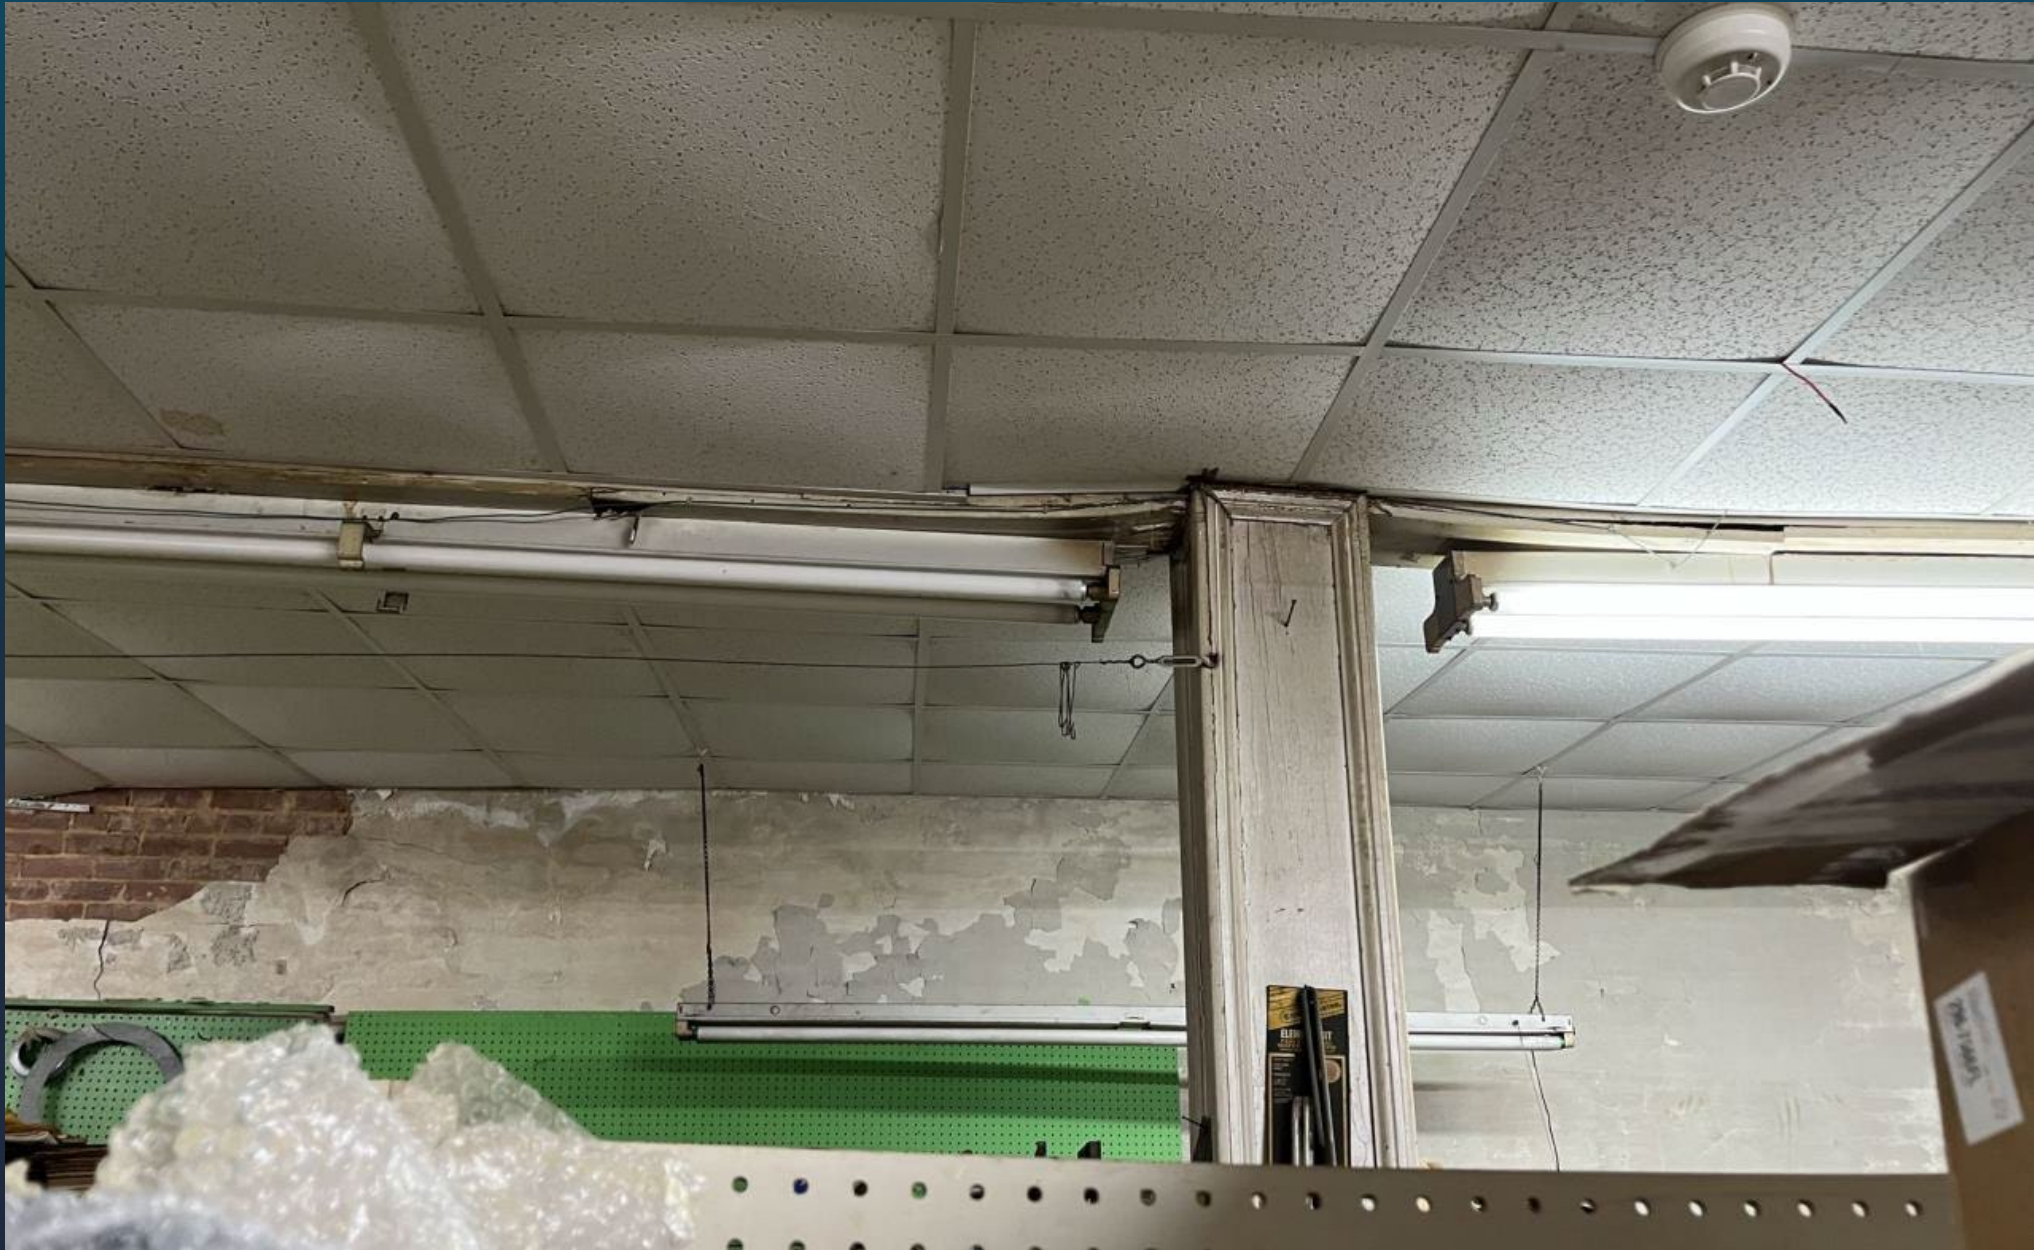
- Severe sagging/deflection of the first and second level floors was observed likely due to the
- excess loading of the floor due to the significant material storage throughout the subject
- building. In our opinion, the first and second floor wood framing is beyond repair. NOVA
- recommends the deteriorated and overloaded 1st and 2nd floor wood frame be demolished
- and reconstructed in kind. It is likely that the perimeter load bearing masonry walls can be
- reused with minor repairs. The roof framing will require removal of underside finishes and a
- follow up structural inspection.
- It is our opinion that the building is in an unsafe structural condition and shall be taken out of
- service until adequate wood frame repairs can be accomplished. The required structural
- repairs should be designed by a professional engineer experienced in restoration.
